# RESEARCH AND INVESTIGATION INTO THE PERFORMANCE OF RAIN WATER TANKS IN BUSHFIRES

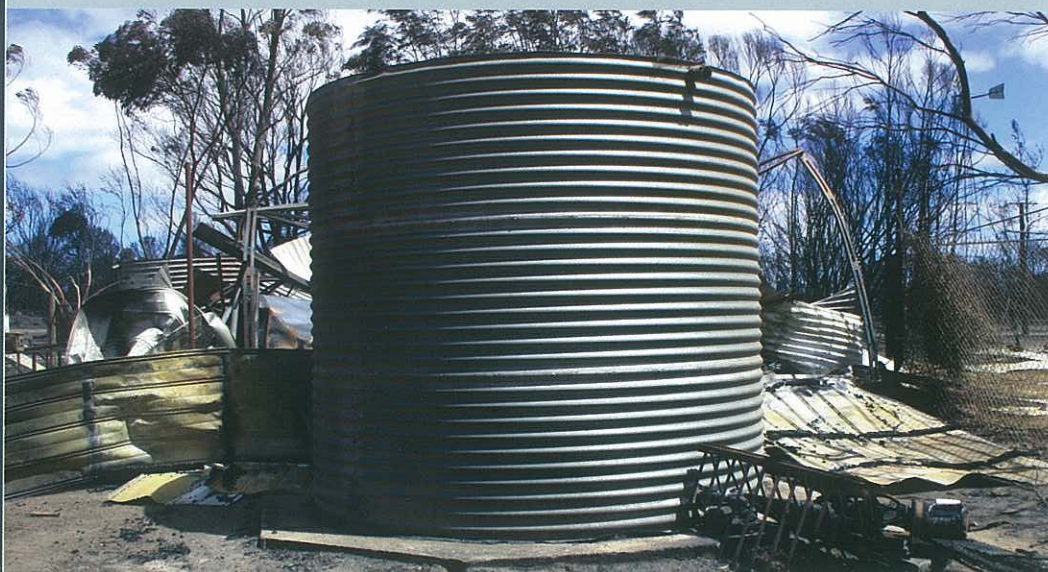
Of the different materials tested, spiral wound, steel tanks performed best under all exposure conditions. All steel manufactured tanks maintained structural integrity when faced with a 30-minute flame immersion test, simulating an adjacent structural fire (see table overleaf for further details on exposure levels).

LEFT: WATERPOINT® CLASSIC DURING TESTING AND ABOVE RIGHT: STEEL CONSTRUCTION TANK AFTER FIRE FRONT

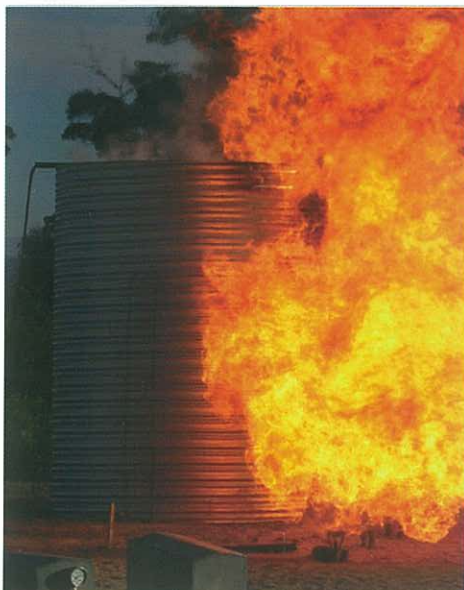
Steel construction liner tanks maintained structural integrity during all tests. The liner construction proved able to retain water during and after the fire-front, which is critical for the protection of property and assets in the event of a bushfire.

RIGHT: PIONEER GALAXY TANK DURING TESTING

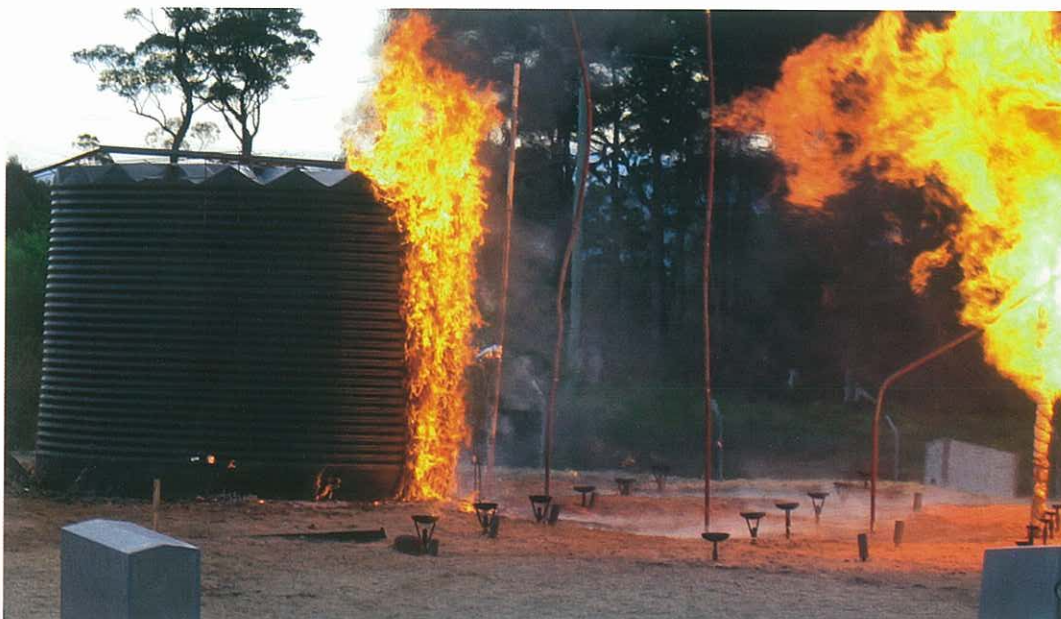
Polyethylene tanks suffered considerable structural distortion during simulation of a bushfire passage. The tanks demonstrated structural deformation during the 30 minute flame exposure, resulting in the tank splitting itself and melting down. Polyethylene tanks were at risk of total failure when adjacent combustible items are present, in the form of forest litter, fences or other polyethylene tanks.

LEFT: TESTING OF POLYETHYLENE RAINWATER TANKS
